Surf and Coastal Area Measurement Platform (SCAMP)

USACE Demonstration Survey Final Report

November 10, 2000

Areté Associates

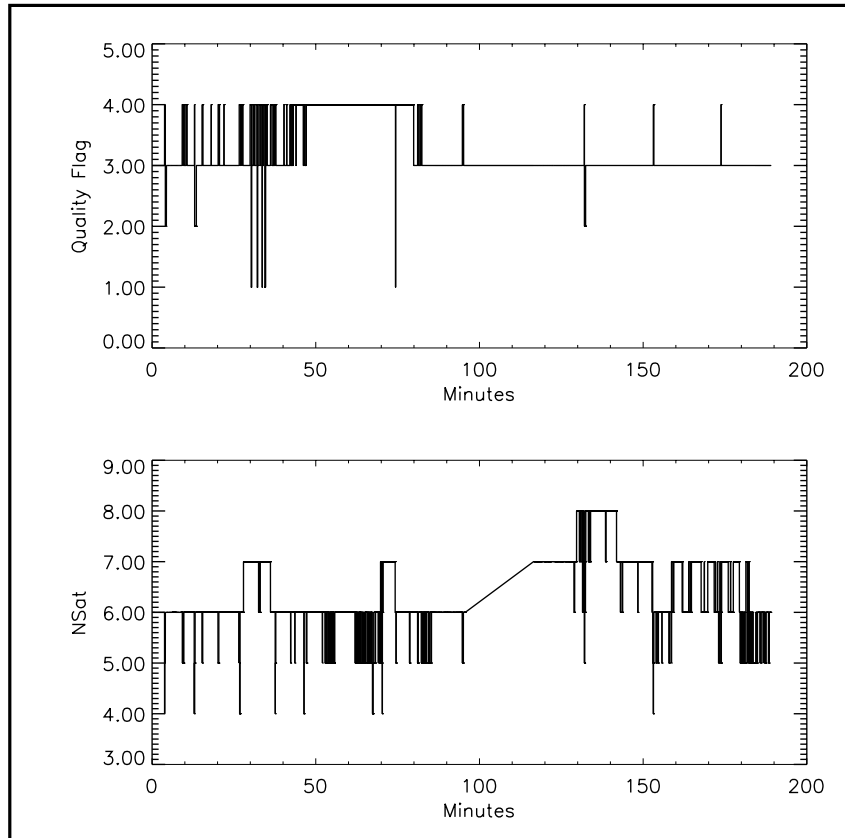
Figure 2: Time series of GPS quality flag and number of satellites used in determining each GPS position for September 27 deployment. Quality flag: 3=kinematic, 4=invalid or unavailable fix, 2=differential, 1=GPS stand-alone

After further analysis, it is believed that the poor RTK GPS positioning obtained on September 27 was due primarily to interference from local radio traffic rather than a result of insufficient satellite coverage as was the consensus while in the field. A summary of the recorded GPS status channels from September 27 is shown in Figure 2. The figure is a two-

panel time series, with the top panel showing the GPS ‘quality indicator’ (a 1, 2, 3, or 4 status) and the bottom panel listing the number of satellites being used to compute the GPS positions. It can be seen that for the first 90 minutes the quality indicator was predominately locked on 4 (Unknown). At the same time, the number of satellites being used to determine the GPS position seldom dropped below five, the minimum number needed to initialize RTK GPS, and never fell below four, the minimum number needed to maintain RTK GPS, once acquired. A nearly identical satellite configuration on September 29 produced excellent kinematic performance in an area 10 miles southeast of this site. As shown in Figure 2, after 90 minutes of poor performance the system abruptly attained RTK GPS positioning and performed nearly flawlessly for the rest of the deployment.

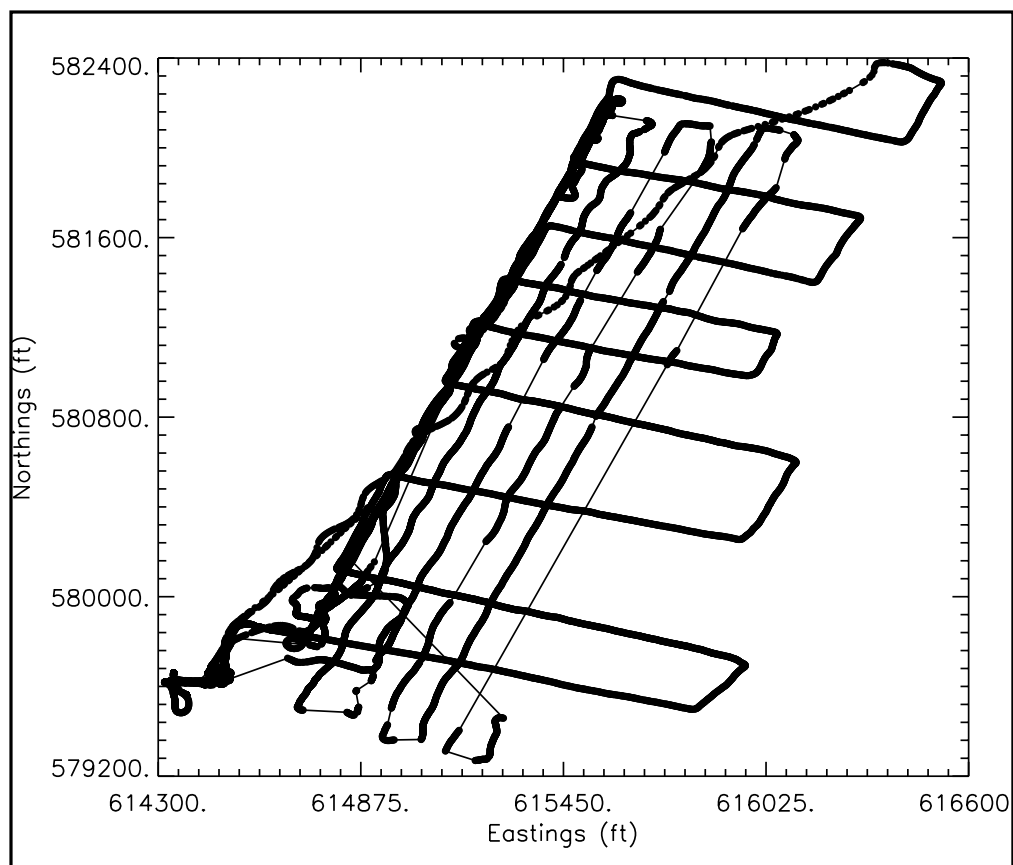
Figure 3: KGPS survey track obtained on September 27. The broken, incomplete track lines are a result of radio interference and (possibly) poor GPS satellite coverage.

The first two of these objectives were met. The line switching option worked flawlessly and the left/right indicator produced excellent results and elicited praise from the jet-ski operator. A quantitative assessment of the improved driving performance using the left/right indicator is shown in a following section. The third objective, however, was not successful. The modifications to the SCAMP drivers for the Trimble GPS and the Datasonics sounder led to significant data drop-outs, timing uncertainties and real-time operational problems. Unlike previous versions obtained from Coastal Oceanographics, this HYPACK®MAX driver did not display the Trimble GPS status flag at the monitor-station operator’s screen. This oversight has since been corrected, but for September 27 and 28, a determination as to how well the system acquired kinematic fixes was not available in the field. Only after post-processing the data was this problem quantified. One of the initial data-quality checks included in the evaluation is a track plot of the good (kinematic) positions obtained during the survey. The survey track for September 27 is shown in Figure 3. The broken line character of the survey track is a result of the system continually losing and then reacquiring kinematic-lock.

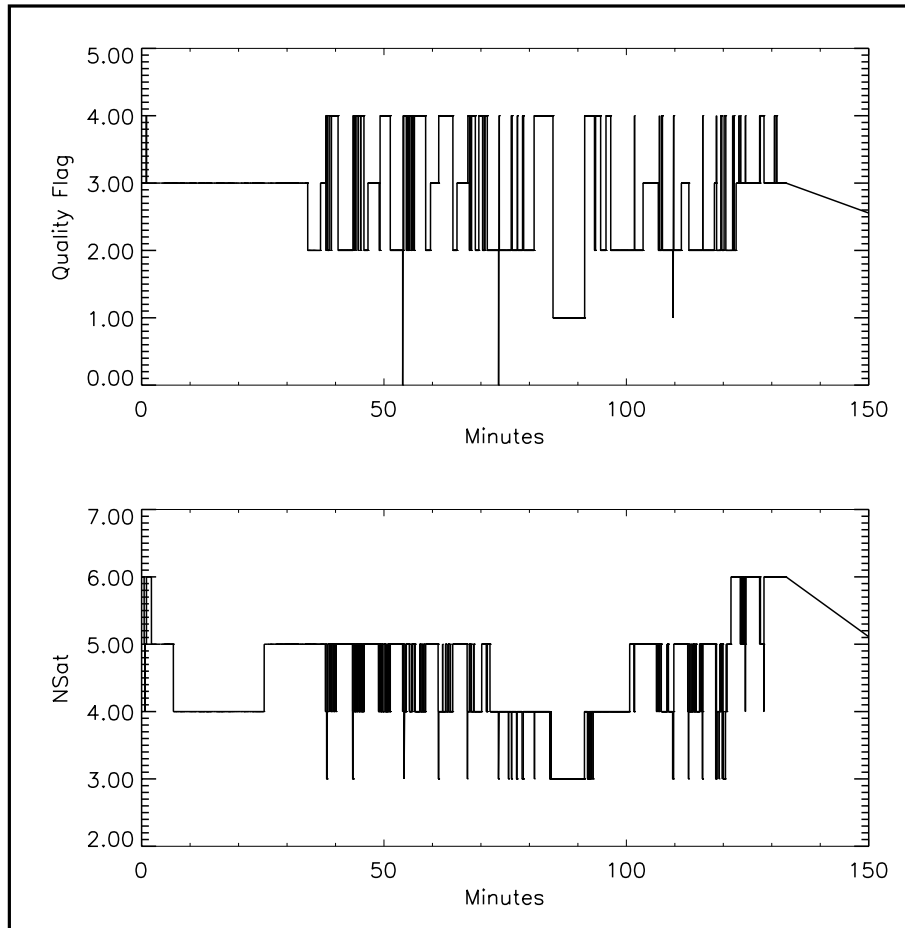
Figure 4: Time series of GPS quality flag and number of satellites used in determining each GPS position for September 28 survey. Due to the low number of available satellites the GPS system was generally in differential mode (quality flag 2).

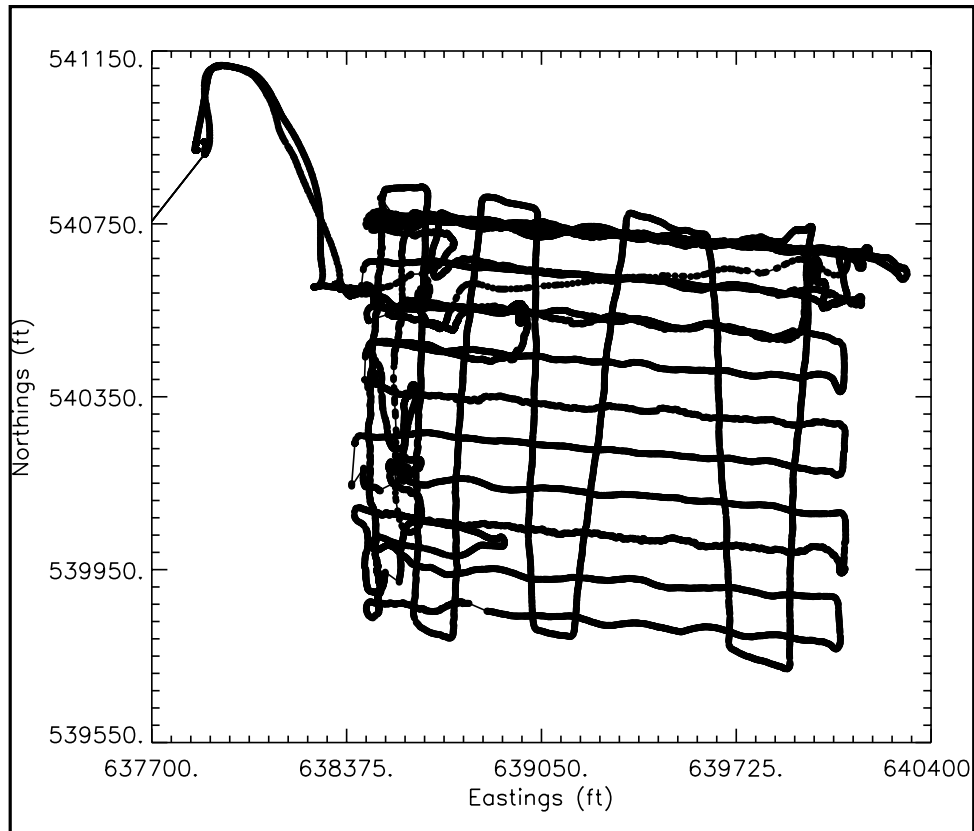
Figure 5: A plot of the full track (kinematic and differential) obtained on September 28. Although the GPS data were not sufficient for bathymetry processing, they did allow a performance analysis of the left/right indicator as an aid to navigating the programmed survey lines, one of the test objectives.

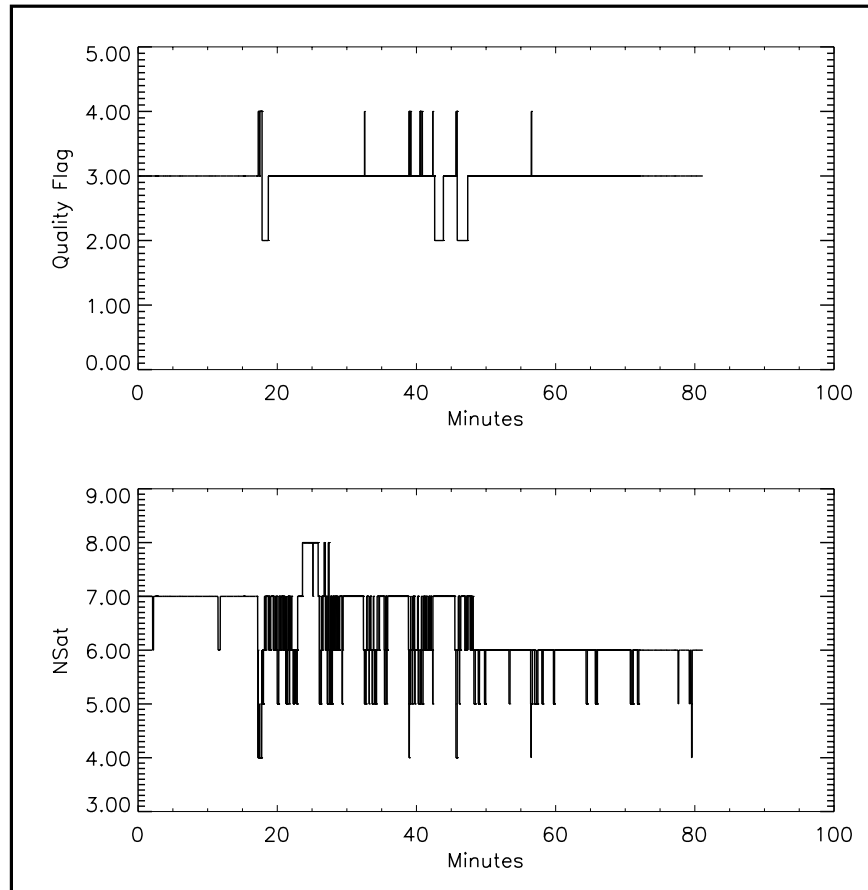
Figure 6: Time series of GPS quality flag and number of satellites used in determining each GPS position for September 29. The nearly constant lock onto quality flag of 3 reflects nearly constant kinematic positioning during the survey.

With these modifications accomplished, the survey was repeated on the morning of September 29. The wind had increased during the night, building the near-shore waves to a marginally operational 1.2 m H_{mo} . System set-up was begun at 7:30 a.m. EDT. The use of an older version of HYPACK® allowed the kinematic flag to be visually checked by the monitor-station operator during the survey. Whenever there was a loss of kinematic navigation noted, the jet-ski operator was instructed to repeat that section of the survey. By 10 a.m. local, the SCAMP field team had completed the survey, loaded the system for transit and was heading back to the Areté Arlington, VA office with what appeared to be a successful kinematic survey in hand. The data quality of the survey is summarized in Figures 6 and 7.

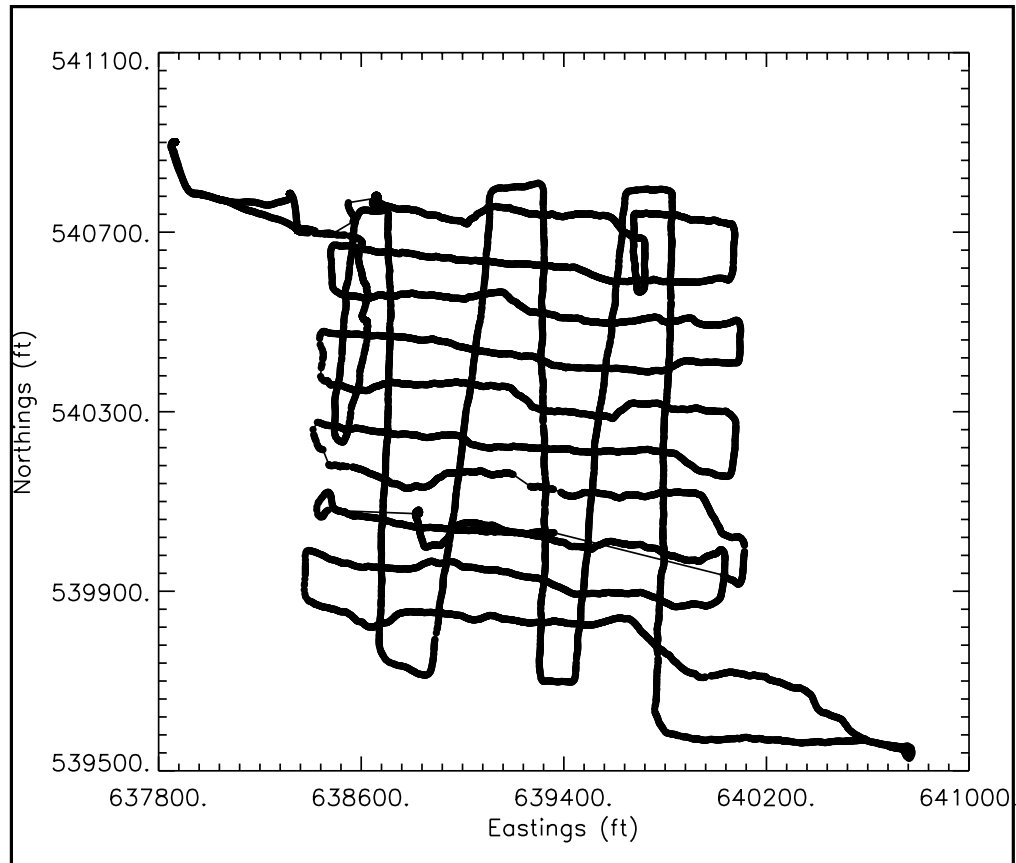
Figure 7: KGPS survey track obtained on September 29.

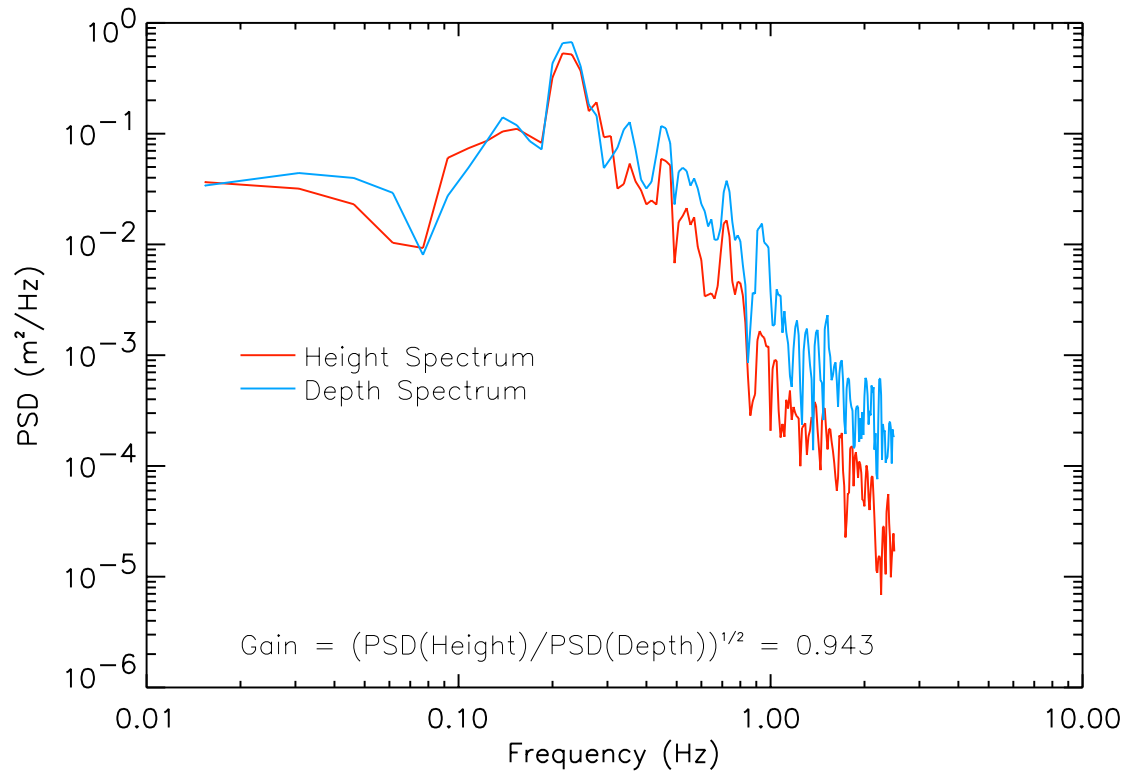
Figure 8: PSDs from GPS antenna height and sounder time series. Relative energy in wave motion band is used to normalize sounder output to local sound speed.

estimated depth. Regardless of the cause, the RTK GPS antenna heights are sufficiently accurate to serve as an *in-situ* calibration of the sounder. The process is summarized in Figure 8. Power Spectral Density (PSD) curves are computed for concurrent RTK GPS antenna height and sounder depth time series, and the spectral levels are compared in the wave-induced boat motion band (in this instance 0.2-0.3 Hz). The square root of the ratio of the integrated variances over this band is the gain (relative sound speed) adjustment. This analysis in spectral space eliminates contributions from unwanted sources. The lower frequency measurements, such as from bottom topography changes, and the higher frequency variations, such as induced by boat roll or sensor digitization, are de-coupled in frequency space. Roll can be included in the de-coupling because each sensor responds to roll at two times the roll frequency and this moves that energy outside of the wave-motion band. Spectral energy peaks associated with roll can be seen in Figure 8 between 0.3 and 0.5 Hz. Normally, this process only would be used to validate the temperature/salinity-derived sound speed. In this instance the analysis is required to verify an apparent documentation error. The Datasonics sounder used in the SCAMP system has recently had a factory replacement e-prom installed. Prior to that install, the sounder-estimated depths were consistent with an assumed sound speed of 1500 m/s. This analysis, and the USACE sled data, indicates an assumed sound speed of 1450 m/s. Datasonics representatives do not yet confirm this, but it should be noted that a similar study two years ago uncovered another documentation error, when it was determined that the sounder reporting rate was 9.1 Hz and not the advertised 10 Hz.

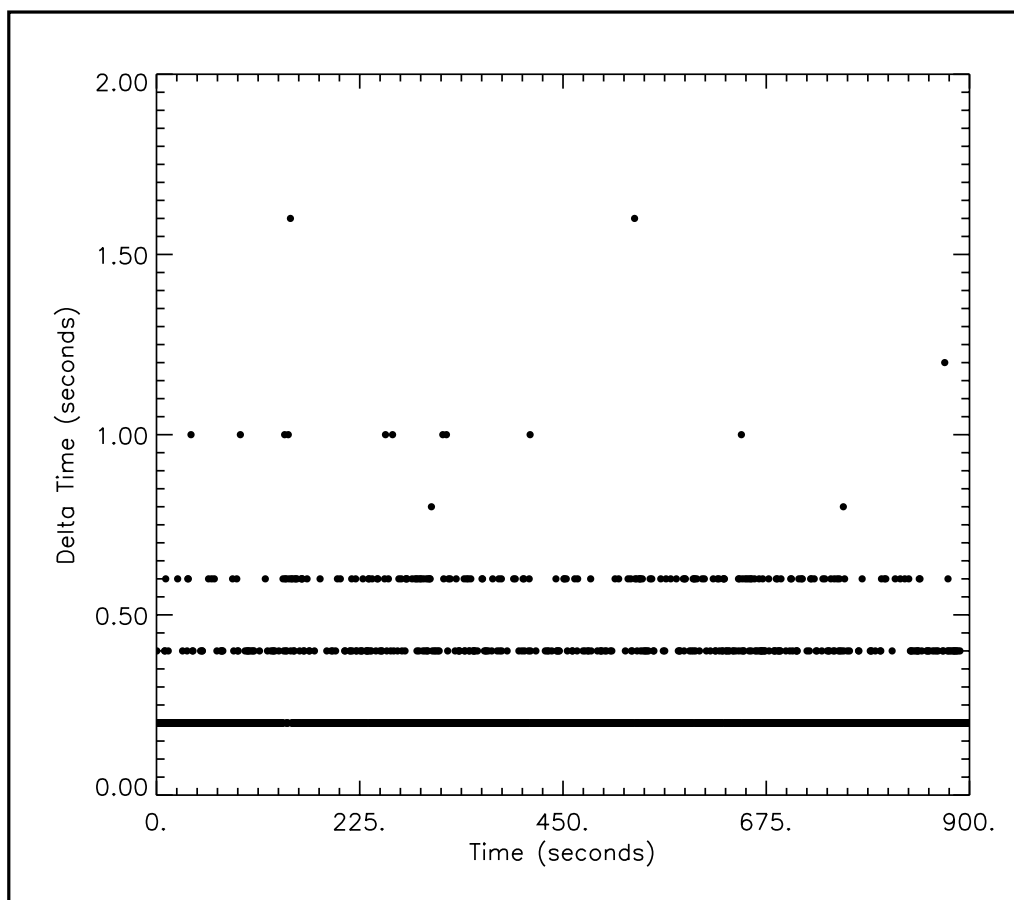
Figure 9: HYPACK delta-t between sequential data points. Reporting rate is 0.2 s. delta-t of 0.4=1 missed GPS update, 0.6=2 missed GPS updates.

The second problem noted above is mitigated in this test by acquiring GPS data at a 5 Hz rate. Had the same number of points (about 20%) been dropped for a data rate of 1 Hz, this problem would have been catastrophic, with two- and three-second time gaps routine. A summary of the HYPACK®MAX acquisition performance is shown in Figure 9. The missed positions are evidently a feature of the new SCAMP sensor HYPACK®MAX drivers created for this test. Though additional analysis is required for verification, there is an apparent correlation between the HYPACK®MAX handling of a sounder error flag and the subsequent skipping of GPS updates. The sounder error flag indicates either a no return from a ping (bubbles in the surf) or depth range exceeded (greater than 30 m). None of the HYPACK® drivers previously used has had difficulty dealing with this error condition.

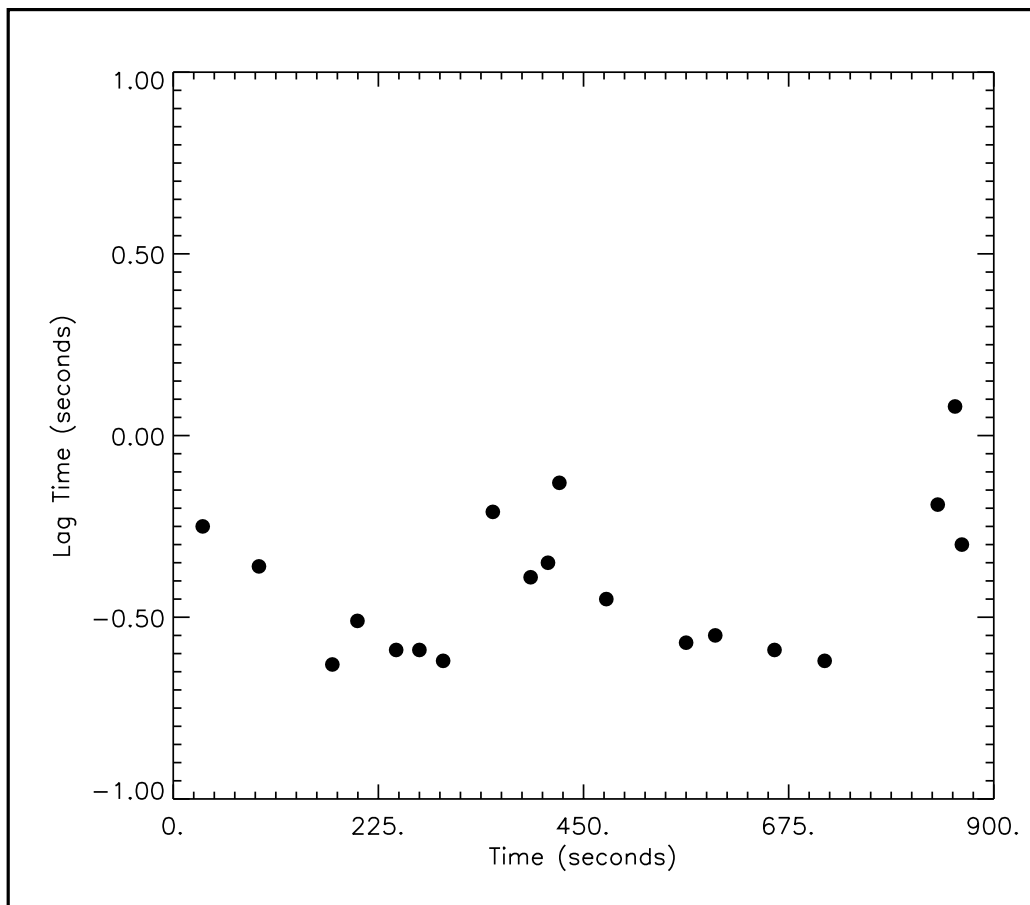
Figure 10: A plot showing the variability in computed lag between GPS height and sounder.

Figure 10 is a plot showing the temporal variability in computed lag between the GPS antenna height and sounder depth. The computed lags in the figure were obtained from two consecutive 15-minute data files on September 27. The computed lags are seen to vary by more than 0.5 seconds, a huge uncertainty when attempting to synchronize the two dynamic measurements. The cause of the HYPACK®MAX timing problem is not yet known, but the impact is easily illustrated. Figures 11 and 12 are similar SCAMP system sounder time series. Each figure depicts a demeaned sounder time series in red and the processed depth, after a synchronous subtraction of the antenna height, superimposed in blue. The performance during this demonstration survey, using the new HYPACK®MAX driver, is shown in Figure 11. The residual error about the trend is about 15 cm rms in seas of 1.2 m H_{mo} , typical for the September 29 data set. Figure 12 was obtained during a 1997 informal survey demonstration at USACE facilities in Duck, NC. That demonstration was run using an older version of HYPACK® for data acquisition. The processed depth-measurement curve has a variability of 5 cm rms, approximately the combined noise level of the RTK GPS height and the sounder measurements. This is typical of past operations. In those instances when SCAMP has been deployed in heavy seas (>1.4 m H_{mo}), the rms error has been somewhat larger due to the effects of roll, but the residual noise has never exceeded 7.5 cm rms. If the increased noise of Figure 11 were assumed due to a degraded sensor performance, it would not be expected to scale with the wave-induced boat motion. But on September 27, when the waves were considerably lower in the sound, the processed depth residual noise was also considerably lower at 9 cm rms. Abnormal performance from either the RTK GPS or the sounder is not indicated. What appears to have occurred is that the use of the HYPACK®MAX delta-t has incorrectly positioned the missing sounder profiles along the time line. The net effect is to shift the sounder data series forward in time at inappropriate locations, thus misarranging the synchronous measurements between sounder depth and RTK GPS height. The timing issues related to the HYPACK®MAX software have been addressed to Coastal Oceanographics and they are investigating the problem with USACE FRF at Duck, NC and Areté assistance.

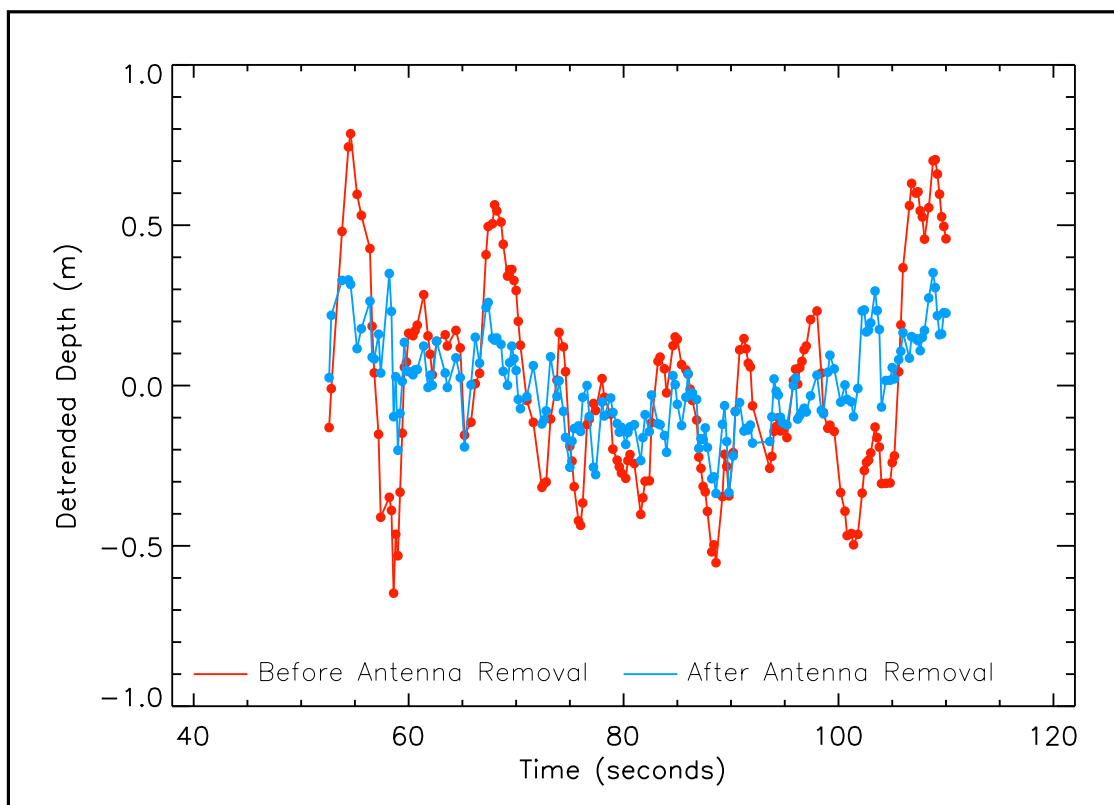
Figure 11: Raw sounder data from September 29 (red) and processed sounder data (blue). Unexpectedly large residual is due to HYPACK®MAX acquisition timing errors.

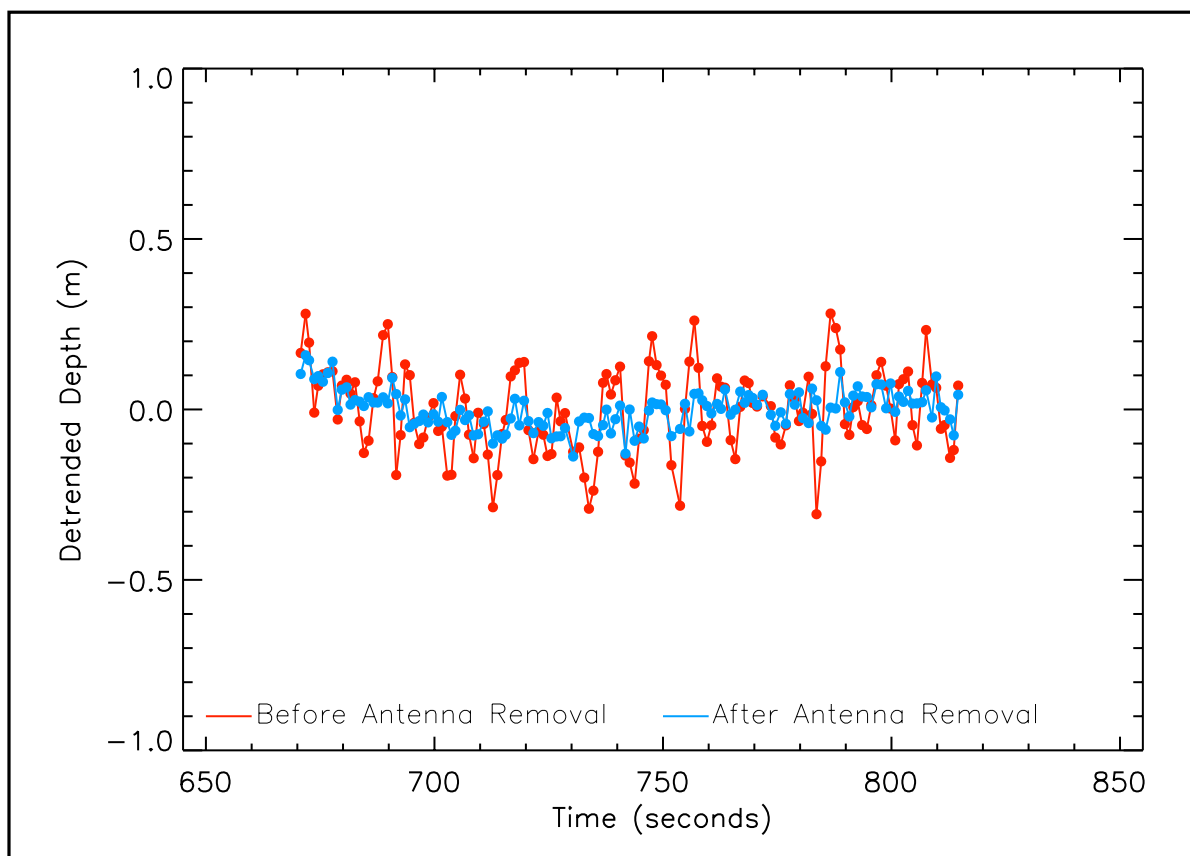
Figure 12: Similar to Figure 11, but obtained in 1997 using older version of HYPACK® acquisition.

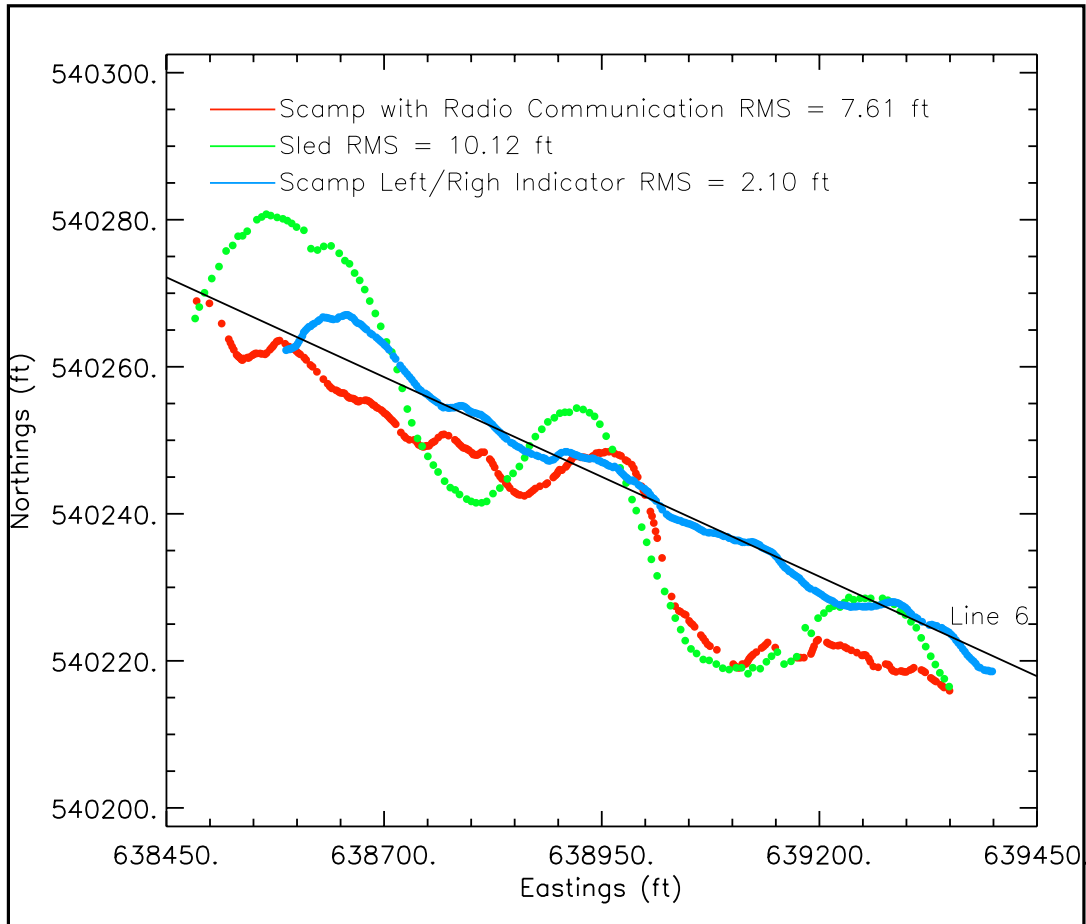
Figure 13: Comparison of line-following accuracy using SCAMP with left/right indicator (blue), SCAMP with voice coms (red), and USACE sled (green). Tracks are plotted in NJ State coordinates.

A substantial improvement in the jet-ski operator's ability to follow the survey line was made possible through the use of the left/right indicator. The left/right indicator was a USACE-requested modification to the SCAMP hydrographic system that was mounted on the steering column in clear view of the operator. Figures 13, and 14 quantify the performance improvement. Figure 13 is a comparison of the (typical) line-following accuracy showing the deviation from the survey line decreasing from 7.6 ft when relying on radio communications to 2.1 ft when using the left/right indicator. The path of the USACE sled (with a deviation from the track of 10.1 ft) also is shown in the figure for comparison. A cumulative probability distribution curve for the composite of all the tracks is shown in Figure 14, which is helpful in quantifying performance. For example, as shown by the two curves, 90% of the time the operator is able to remain within 2 m of the survey line while using the left/right indicator. However, the operator is only able to remain within that range 25-30% of the time when directed by the monitor-station operator by radio communications. The SCAMP operator has attested to an additional value to the use of the indicator. Not only was the navigation improved, but also an increase in the safety was afforded by this addition. According to the operator, while using the indicator as a steering command, the driving demand was simplified, enabling a more vigilant watch for rogue waves while in the surf-zone.

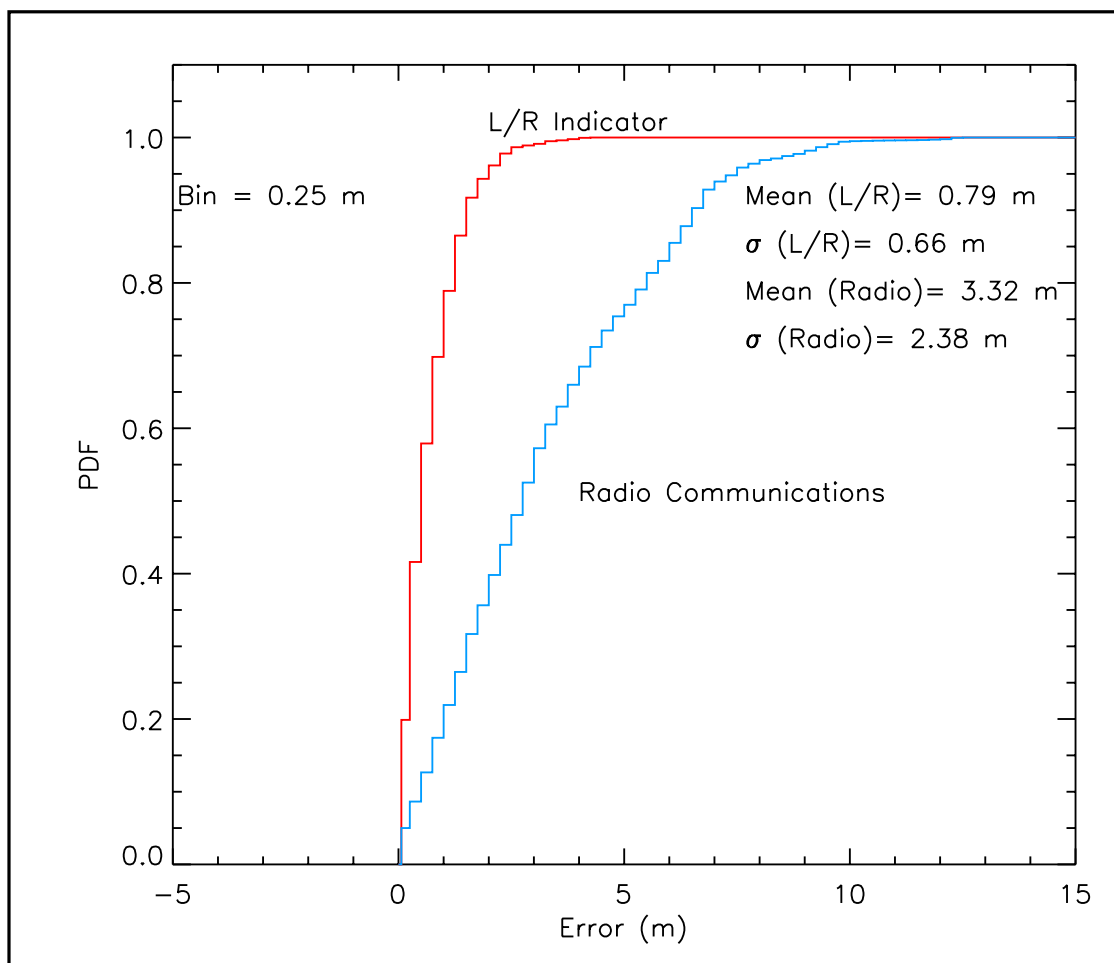
Figure 14: Cumulative distribution curves of distance from track line for two SCAMP driving techniques: using Left/Right indicator (red), and using voice radio communications (blue).

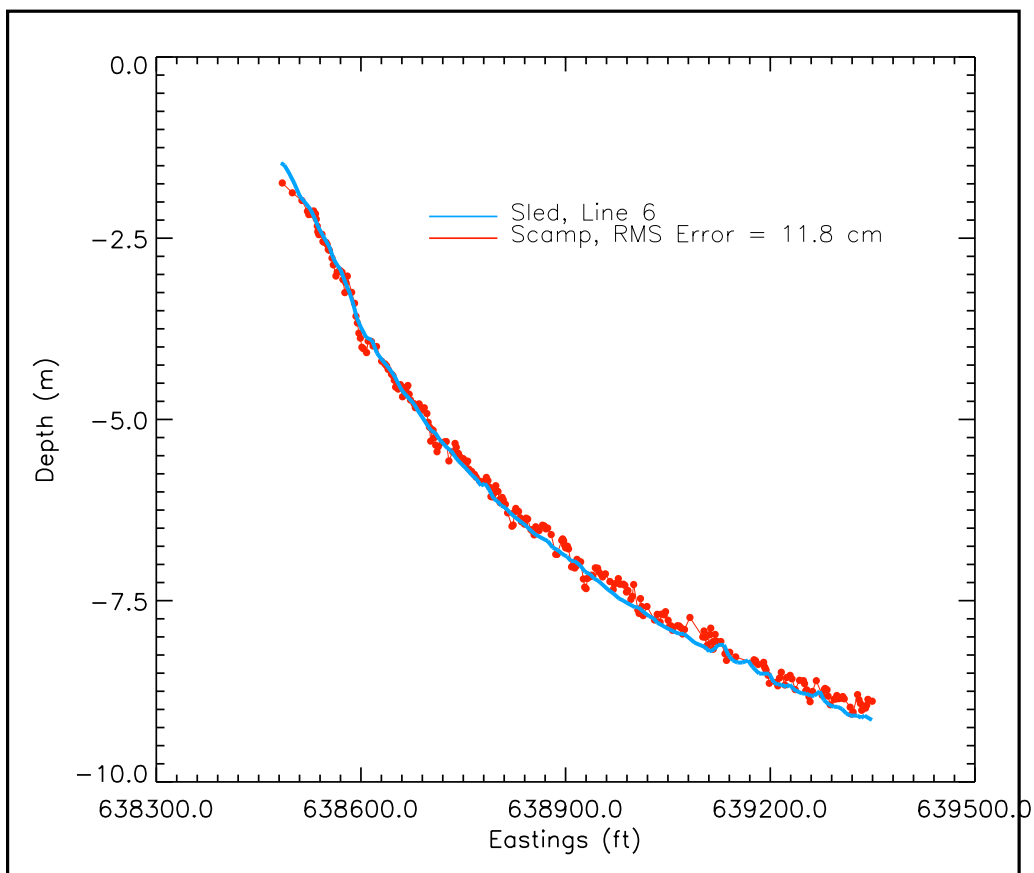
Figure 15: Comparison between USACE sled (blue) and SCAMP hydrographic system profiles obtained from line 6 of survey grid. Large rms error is largely due to the HYPACK®MAX timing problem.

The third demonstration objective, to obtain collocated bathymetric data and provide a comparative performance analysis between the SCAMP hydrographic system and the USACE standard towed sled, was not as successful as had been hoped. Excellent hydrographic profiles of the target survey lines have been obtained from the USACE New York District and compared to those obtained during the SCAMP demonstration survey. Two of the profile comparisons are shown in Figures 15 and 16. The relatively smooth blue line in each figure is a sled profile. Note in each figure that the SCAMP profiles generally follow the mean depth of the sled profiles but separate slightly at the deep end. This indicates a slight error in the sound speed adjustment of the SCAMP sounder. This is most probably caused by an underestimate of the RTK GPS height variance in the wave-motion band, a result of HYPACK®MAX's large number of missed GPS points. The more significant problem is that each of the SCAMP profiles is plagued with the large residual variance from the boat motion due to the HYPACK®MAX timing error discussed above. This produces the 10 to 22 cm sounder noise and that same value of rms error between the SCAMP and sled profiles. An example of an earlier (1997) informal comparison between the SCAMP hydrographic survey system and the USACE CRAB in Duck, NC is shown in Figure 17. The 1997 comparison was conducted using an older version of HYPACK® that did not exhibit the timing problem. At that time the comparison produced an rms error of 5 cm. It is most probable that the use of that older version of HYPACK® would have produced similarly acceptable results here.

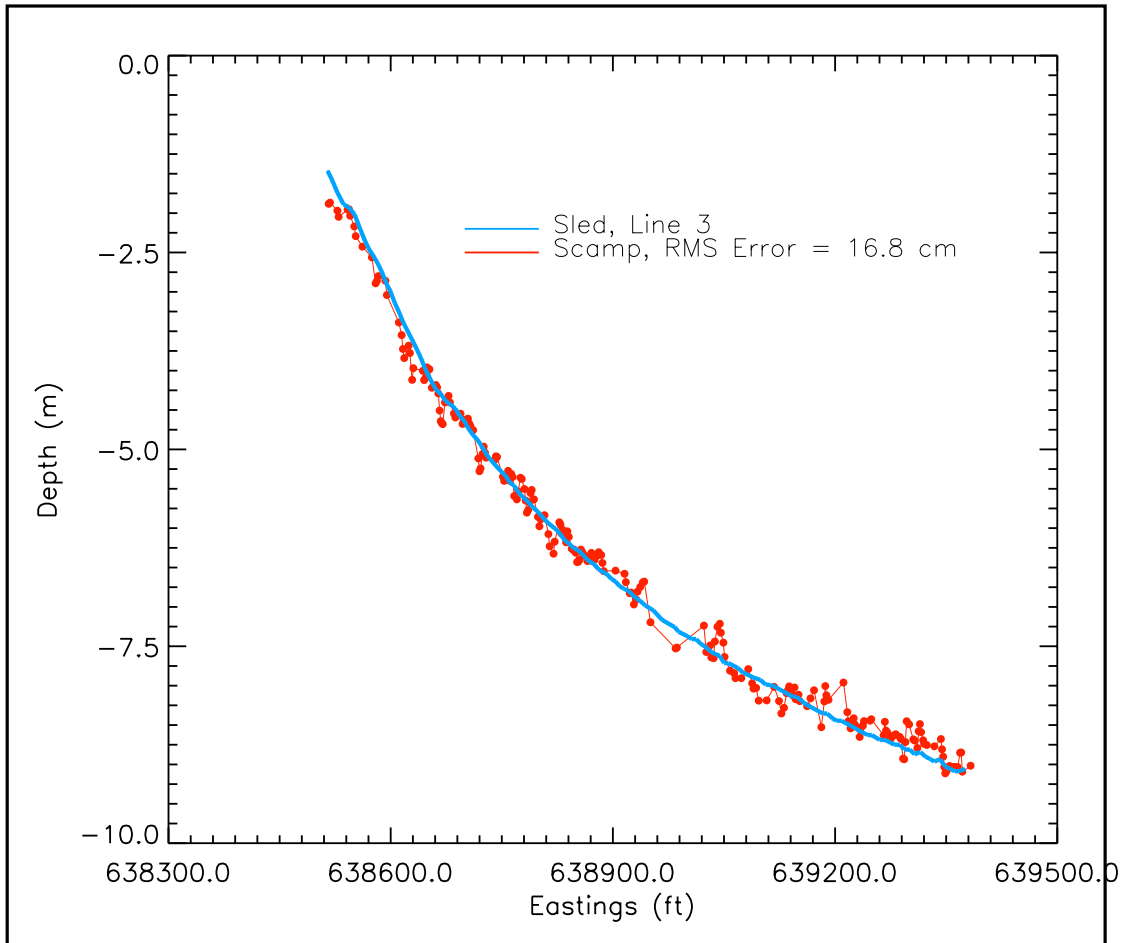
Figure 16: Similar to Figure 15. Residual noise from the HYPACK® timing problem varies with the number of incorrectly positioned time gaps. Here the rms error is near the largest observed, 16.8 cm.

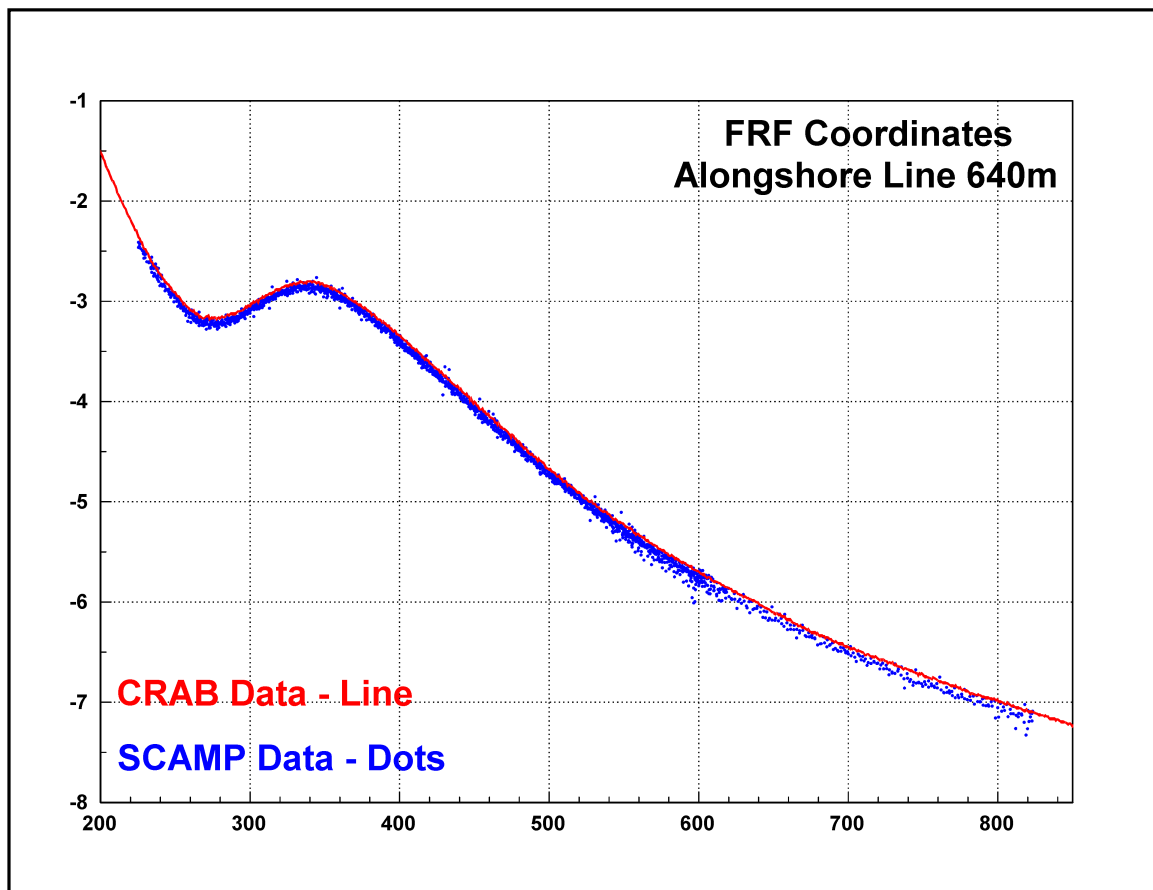
Figure 17: Profiles from an informal survey comparison between SCAMP (blue) and USACE CRAB in 1997. The comparison showed 5 cm rms error. SCAMP system included older version of HYPACK® acquisition software that did not exhibit the timing problems noted in this demonstration.
